METEOROID/SPACE DEBRIS IMPACTS ON MSFC LDEF EXPERIMENTS

Miria Finckenor

NASA/Marshall Space Flight Center (NSFC)

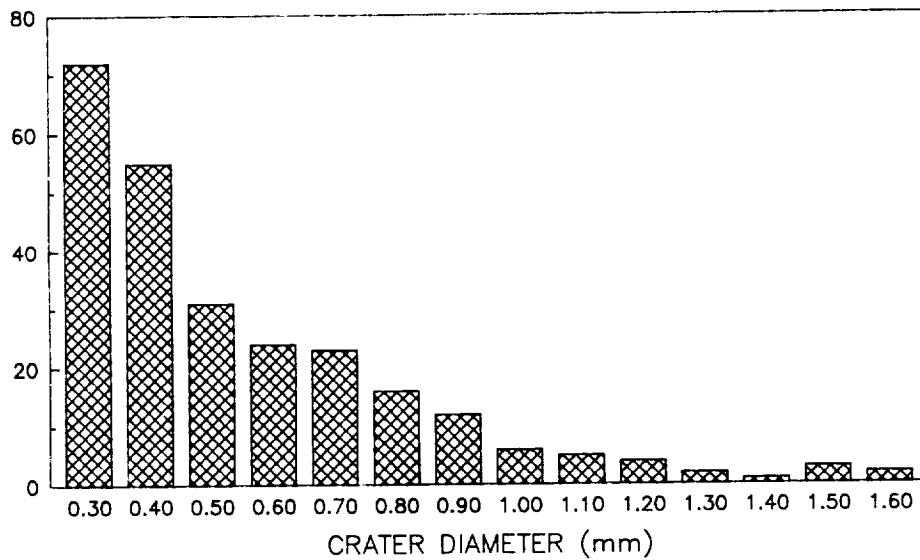
METEOROID/DEBRIS IMPACTS ON MSFC EXPERIMENTS LEADING EDGE TRAYS

NUMBER FOUND ON MSFC TRAYS

TRAYS A08, B10, C09

EXPERIMENTS A0171, S1005, A0034
